# Highway Bridge Inspection Report

**RAWSON AVENUE  
RAWSON AVENUE  
over  
MEGUNTICOOK RIVER**

**Inspection Date:** 03/18/2019

Structure Number: 3173

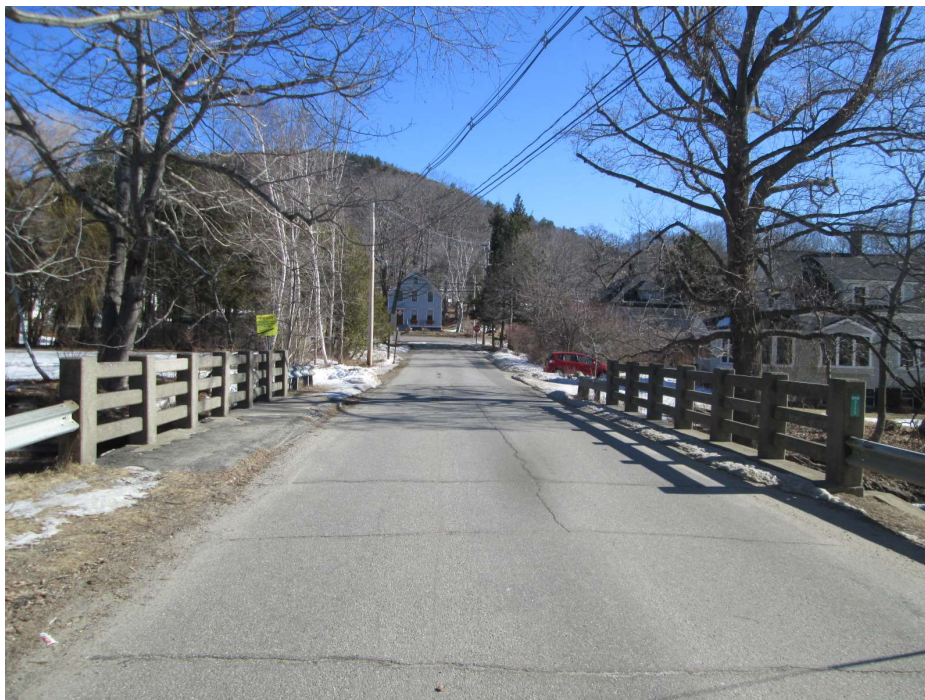
PHOTO 1

Description Roadway looking West

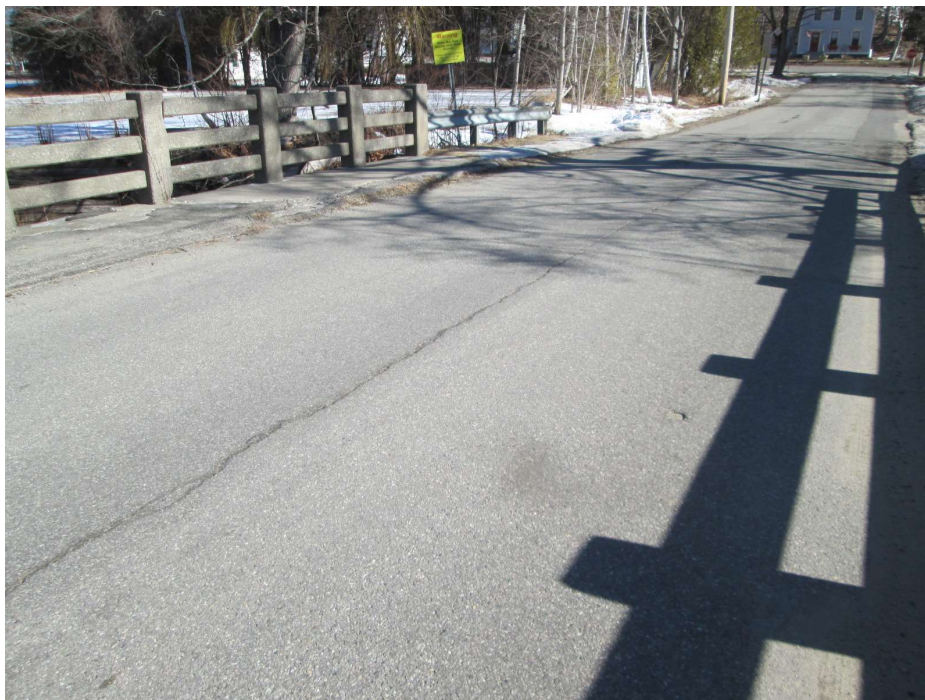
PHOTO 2

Approximately 20% cracking bituminous wearing surface.  
Built up layers of bituminous are masking underlying deck issues.  
The side walk has been patched with asphalt.

Description Bituminous Wearing Surface View - Moderate Cracking

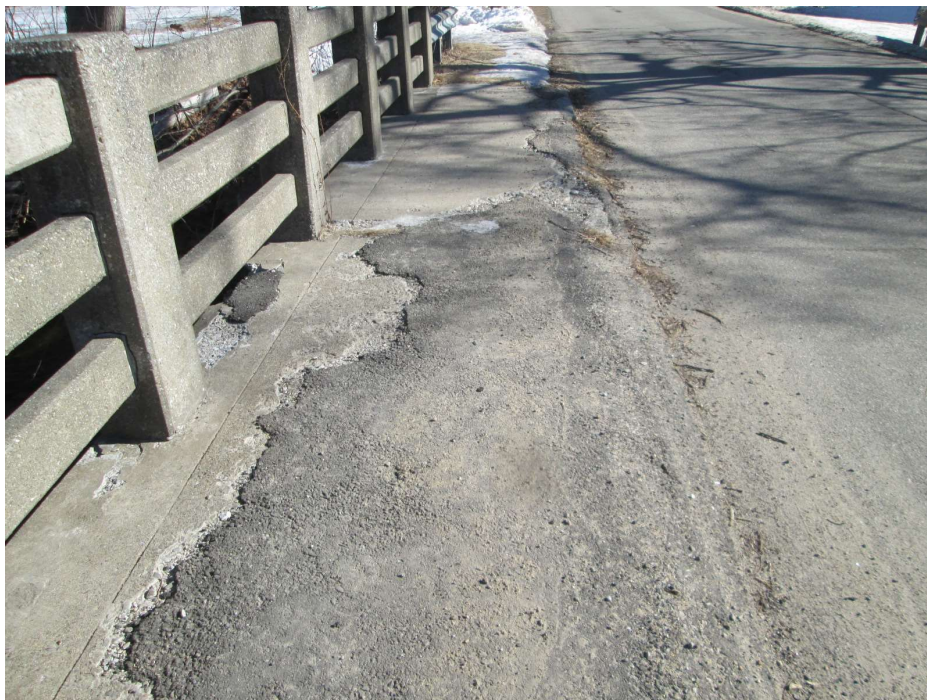
PHOTO 3

Description Concrete Sidewalk - Large Bituminous Patches

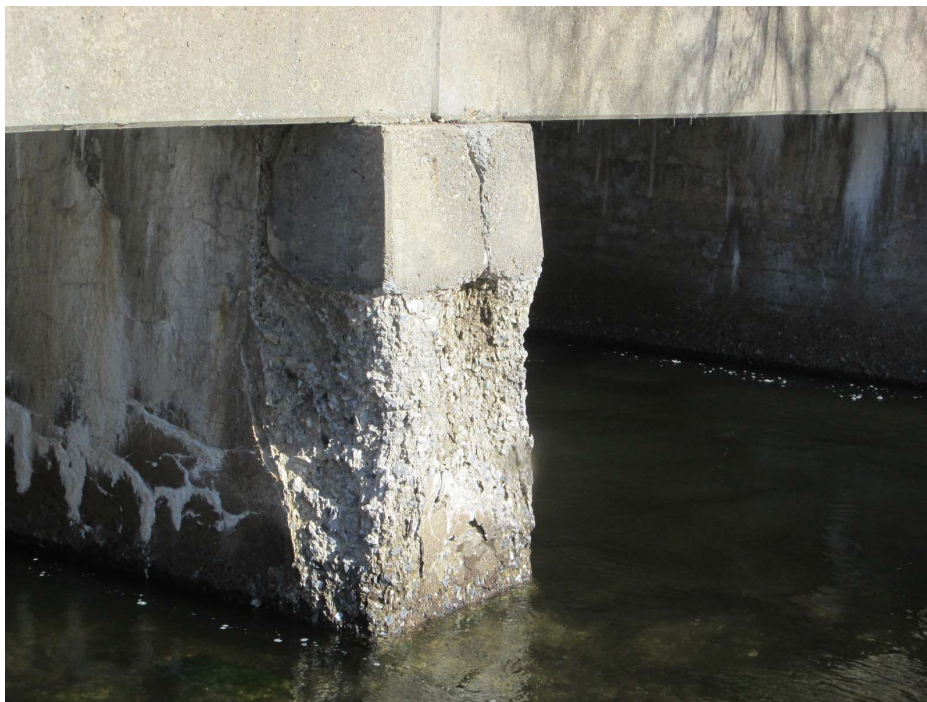
PHOTO 4

Heavy scaling and cracking of pier nose both at up and down stream ends. Downstream end has large spall with delam up to 6" deep full height.  
Heavy staining of pier breastwalls with extensive active efflo and delaminating with crumbling concrete.  
see latest U/W report for details on exposed abutment footings.  
NW wing has heavy erosion behind it from high water events.  
Moderate scaling below waterline.

Description Pier View - downstream - Heavy scaling

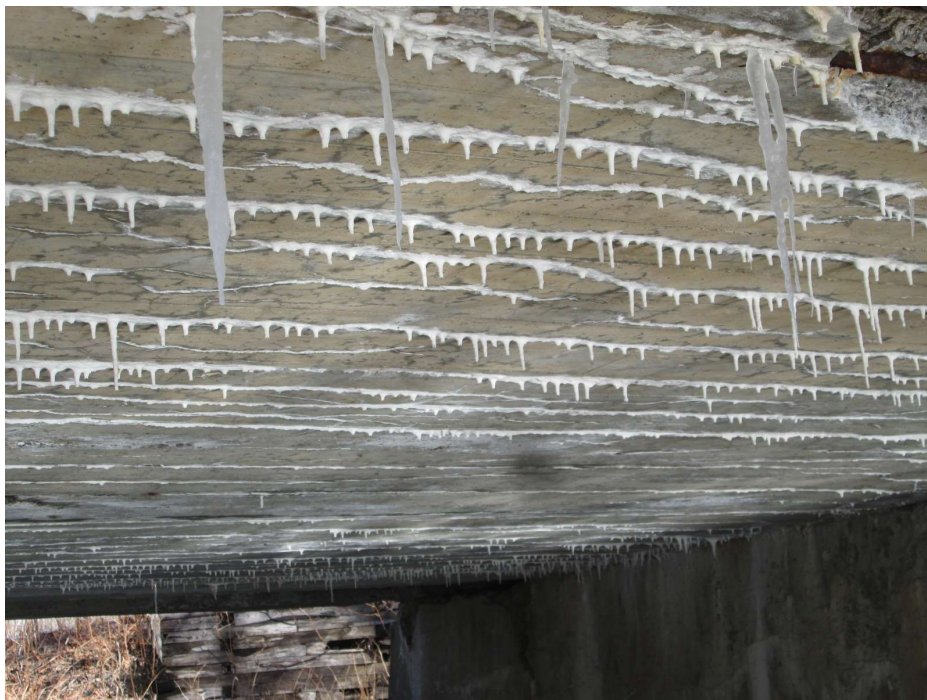
PHOTO 5

Bottom of slab has 100% extensive longitudinal cracking with very active efflo stalactites and rust staining.  
Bottom of the slab has 25% delaminated concrete and 5-10% spalled with exposed re-steel.  
Upstream fascia at pier has spalling with delam and efflo.  
Diaphragm under sidewalk at piers and abutments has approximately 50% spalls and delam.  
Slab under sidewalk/curb in North span has 18"+/- deep x 20"+/- high spall for approximately 11ft with multiple exposed reinforcing bars.

Description      Slab View - West Span - Heavy Cracking with active efflo

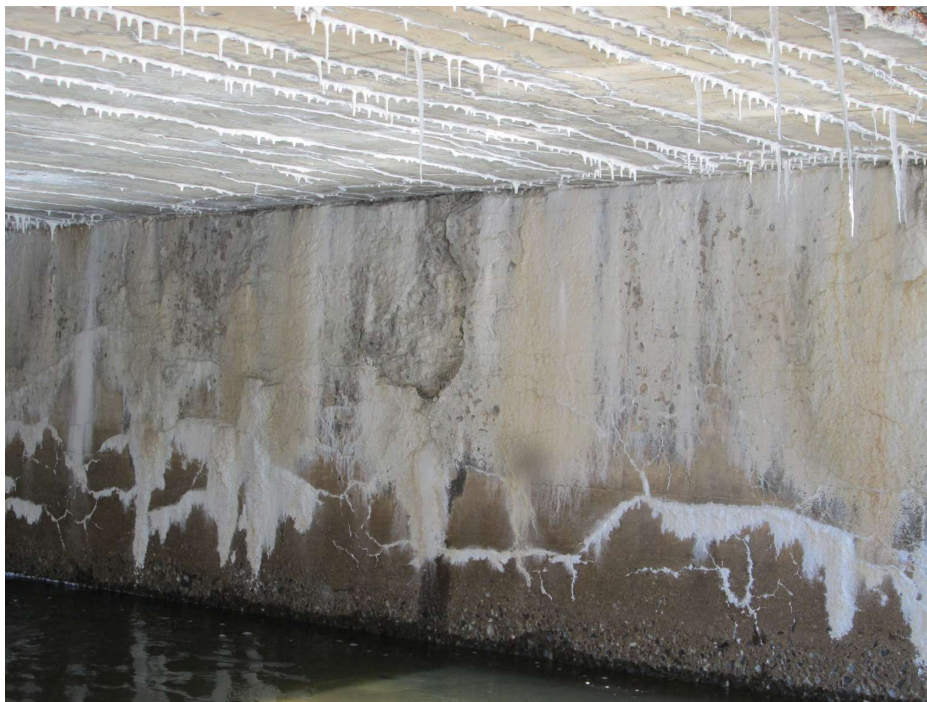
PHOTO 6

Description      Pier View - West Side - Cracking Staining and Efflo

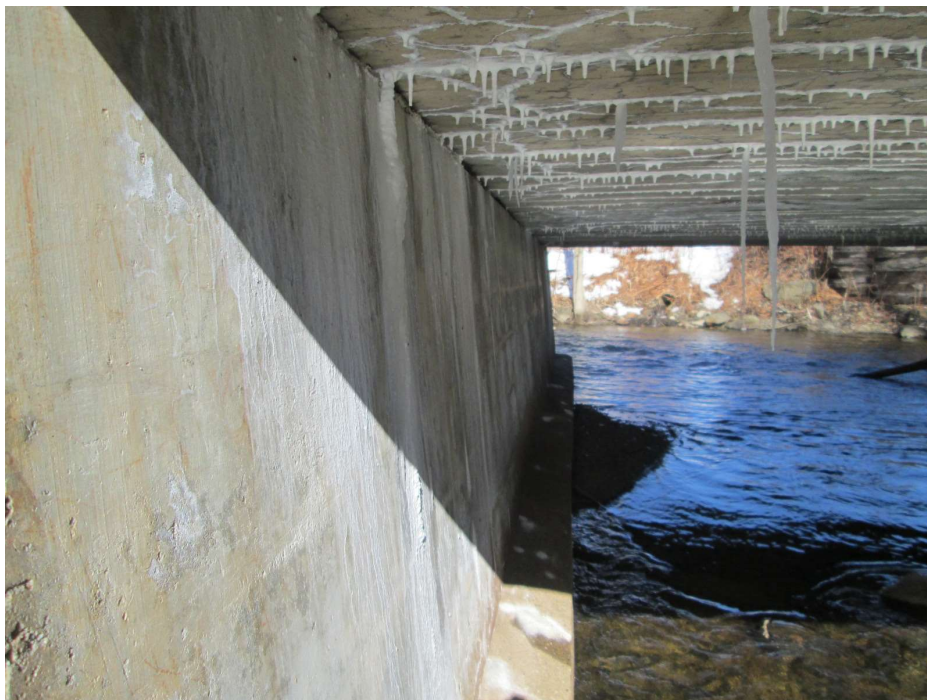
PHOTO 7

Description West Abutment View - Footing exposed

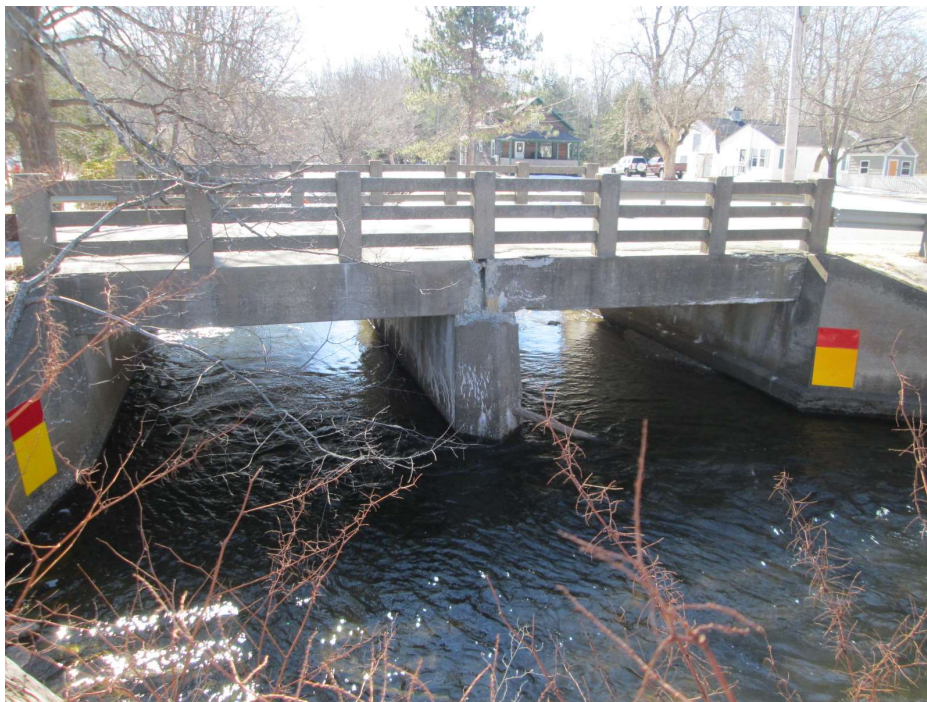
PHOTO 8

Description View looking downstream

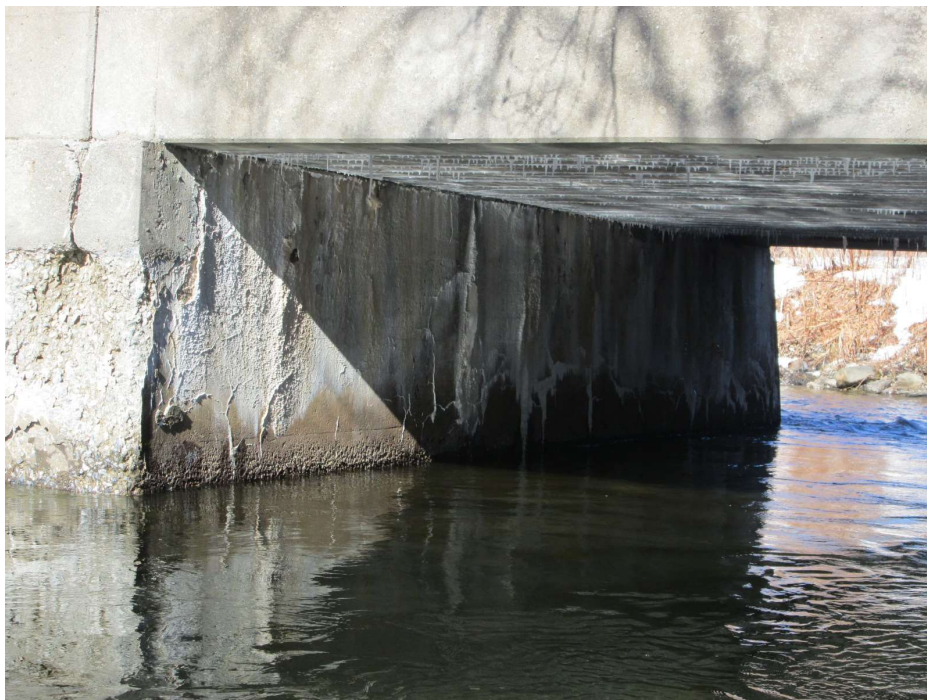
PHOTO 9

Description Pier View - East Side - Delamination and efflo

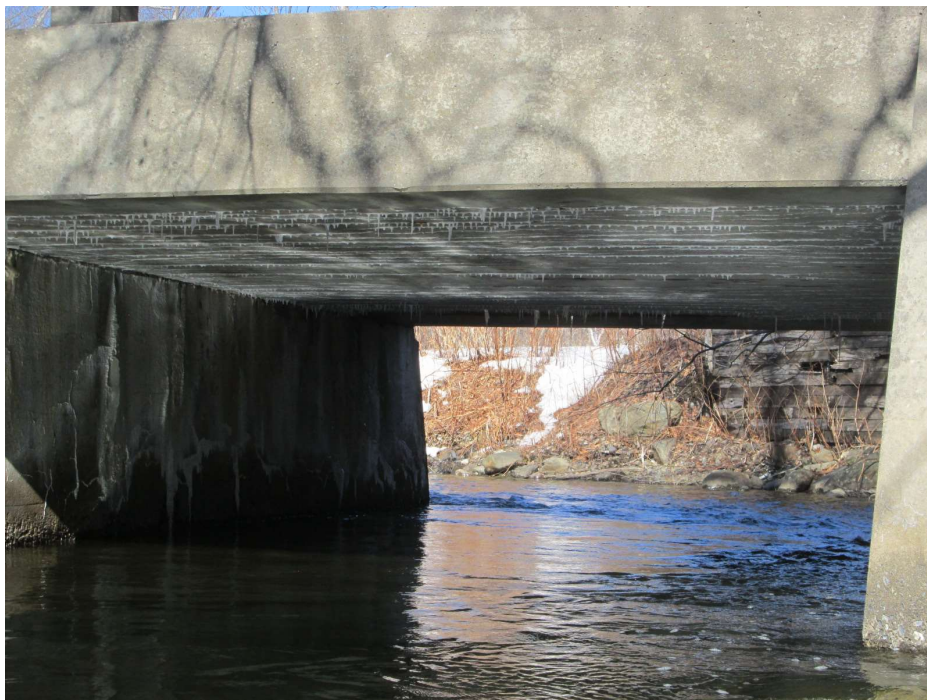
PHOTO 10

Description Slab View - East Span - Cracking with active efflo

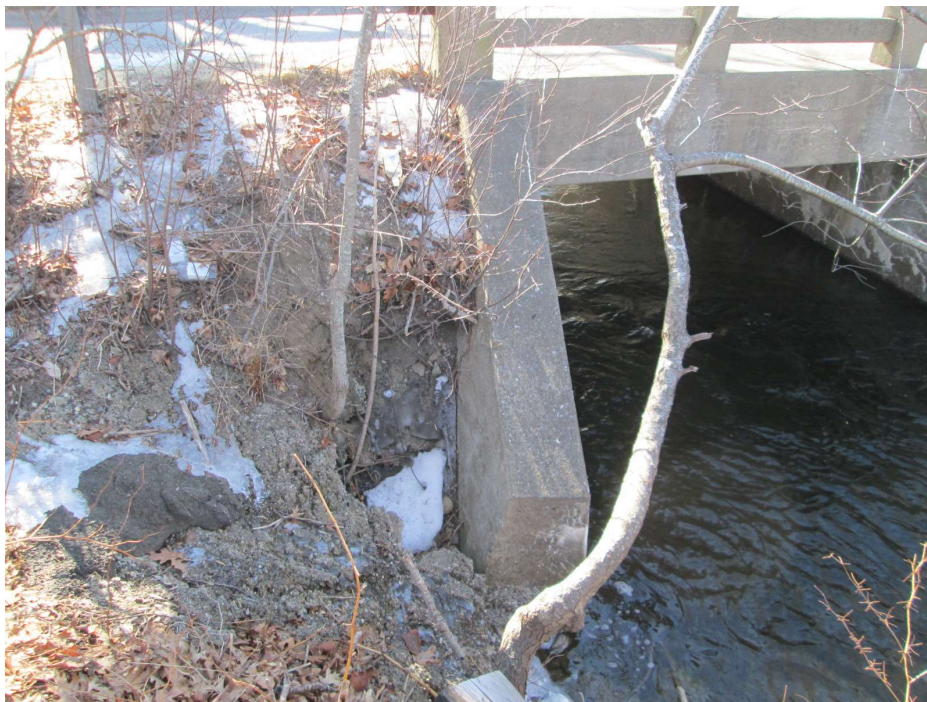
PHOTO 11

Description NE Wing - Past Concrete Scour repairs failed

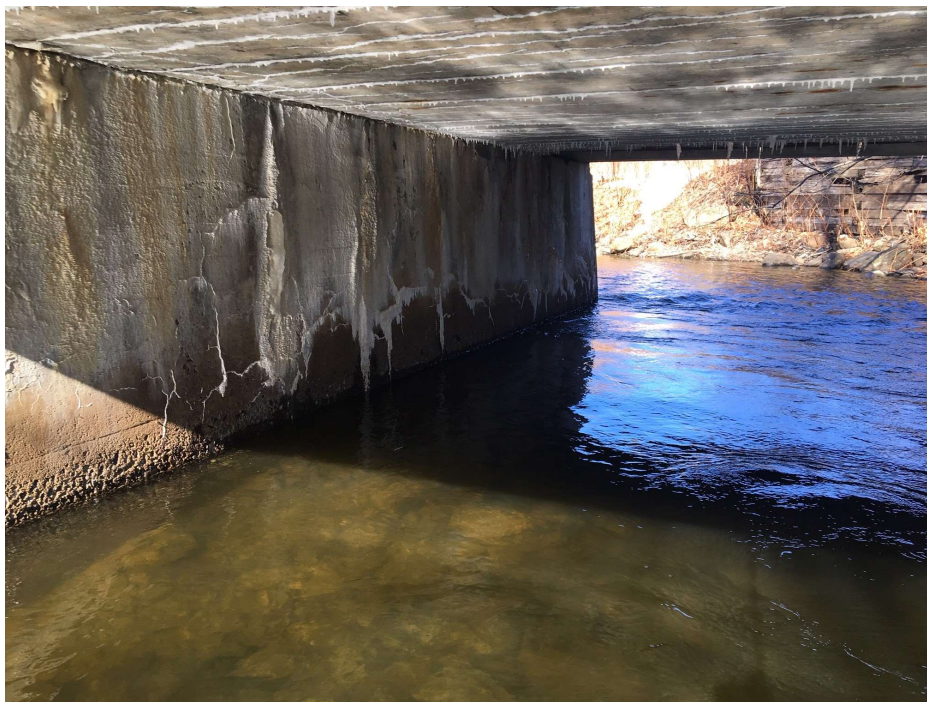
PHOTO 12

Description Pier View - East Side

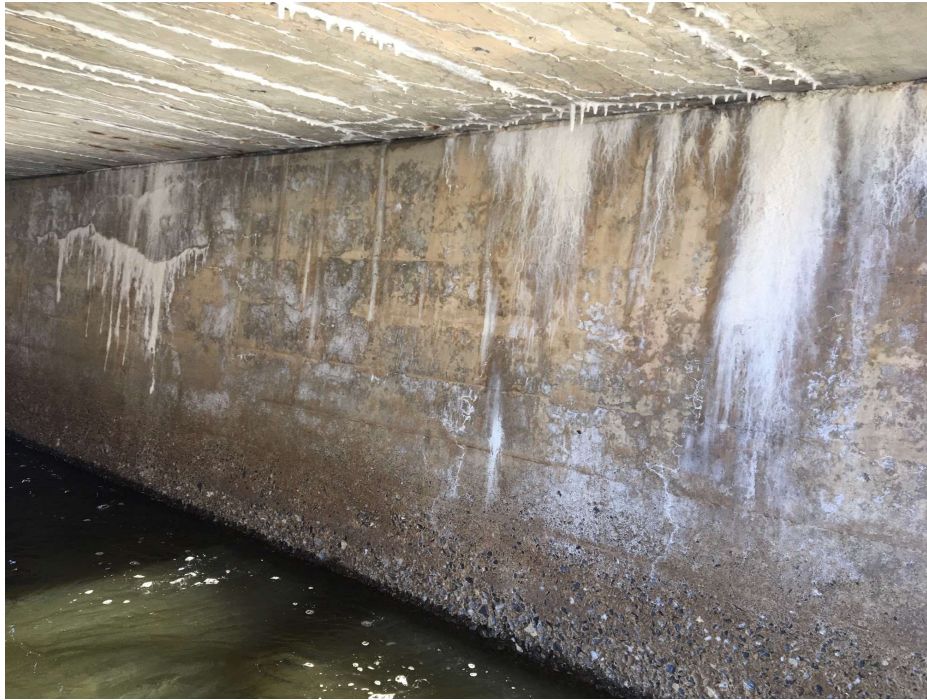
PHOTO 13

Description    East Abutment View
